METALS HANDBOOK

VOL. 9
FRACTOGRAPHY AND ATLAS OF FRACTOGRAPHY

8th EDITION

Fractography and Atlas of Fractographs

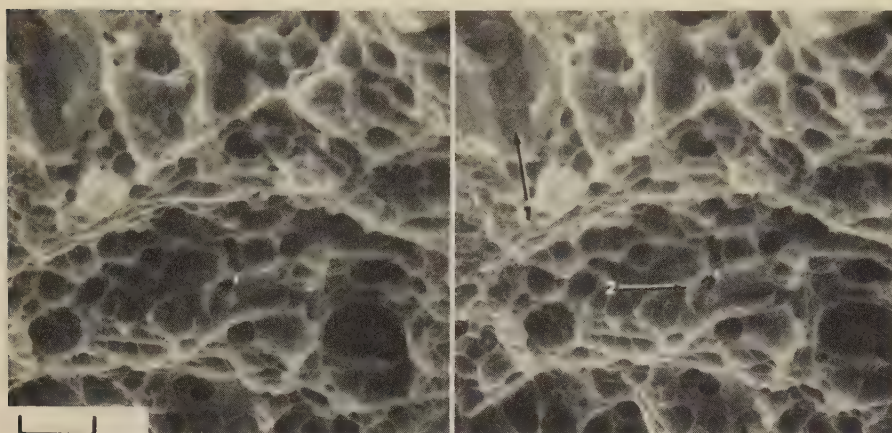
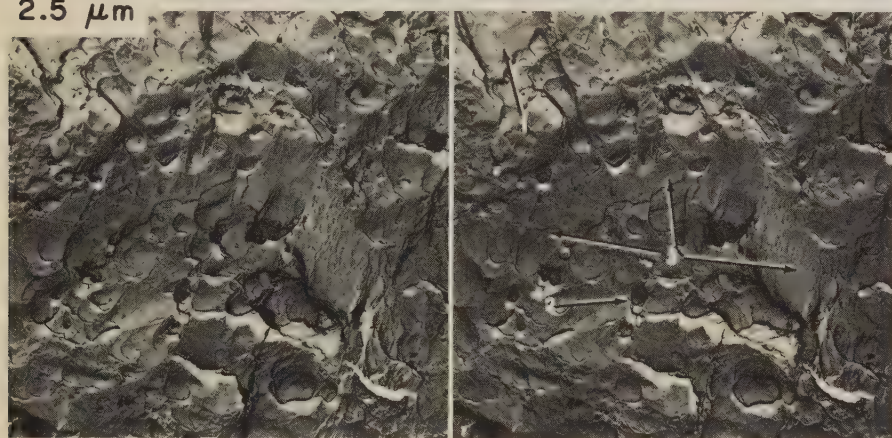
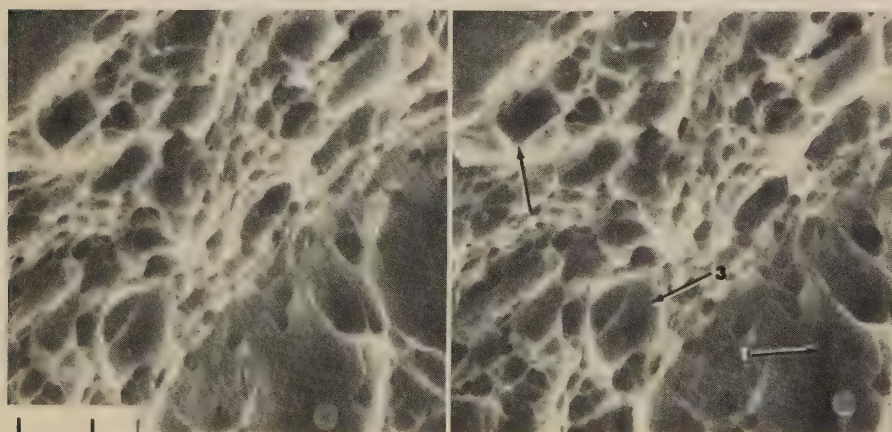
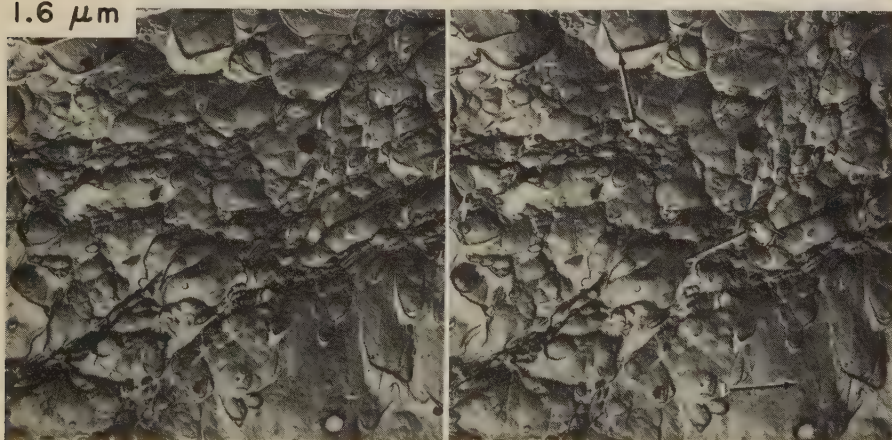
SEM (4228) and TEM (4229) stereofractographs 4000×

4228 Fracture surface of a notched specimen of

260 C (500 F) and air cooled to give a hardness of Rockwell C 50, then broken by tension overload at room temperature. The surface is dimpled, with at least one area (at arrow 1) showing some evidence of stretching. At first glance, the TEM pair appears to bear little resemblance to the SEM, but careful scrutiny in 3-D of the sites at arrows 1 and 2 establishes that they are indeed identical. The major area of departure appears to lie in the regions marked 3 in the TEM pair. Study of the SEM pair shows that the direction of observation is essentially tangential to these regions, which are not visible because of overhang. An SEM view of this area taken at a 30° angle (not shown) disclosed stretched regions containing the same dimples as those in the regions marked 3 in the TEM pair. See also 4230-4231, below.

4230 A higher-magnification set of views of another area in the tension-overload fracture in the notched specimen of 4340 steel

4231 in 4228-4229, showing a somewhat similar fracture surface consisting predominantly of dimples. Unlike 4228-4229, the SEM and TEM pairs here are readily recognized as showing the same fracture contours. The features indicated by arrows 1, 2 and 3, for instance, are obviously the same in both pairs. Even the inclusion at arrow 1 can be seen in both the SEM and the TEM. Note that in the TEM replica, the shapes of both the large and small dimples bear a very close resemblance to those of the dimples in the SEM pair; this is even more apparent when the stereo pairs are viewed in 3-D. Note particularly the features displayed in the stretched dimple at arrow 1; each contour found in one pair can be identified in the other.

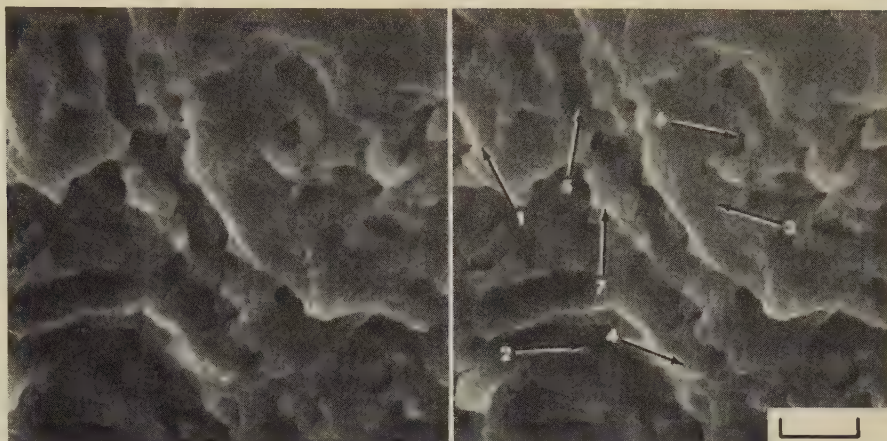
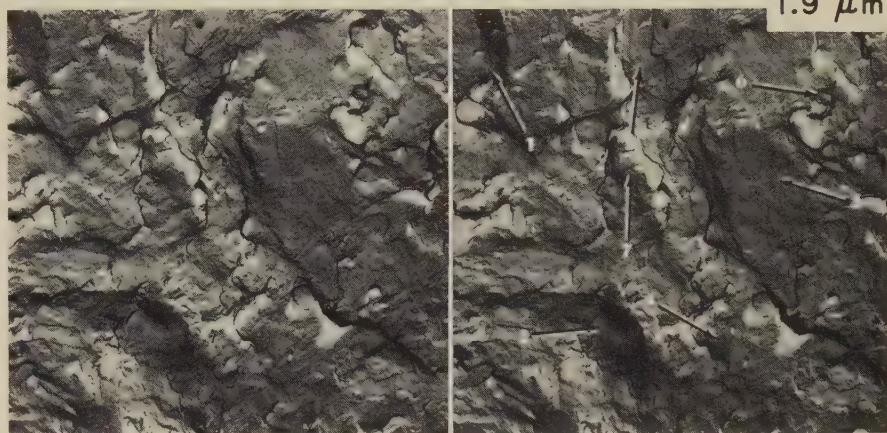
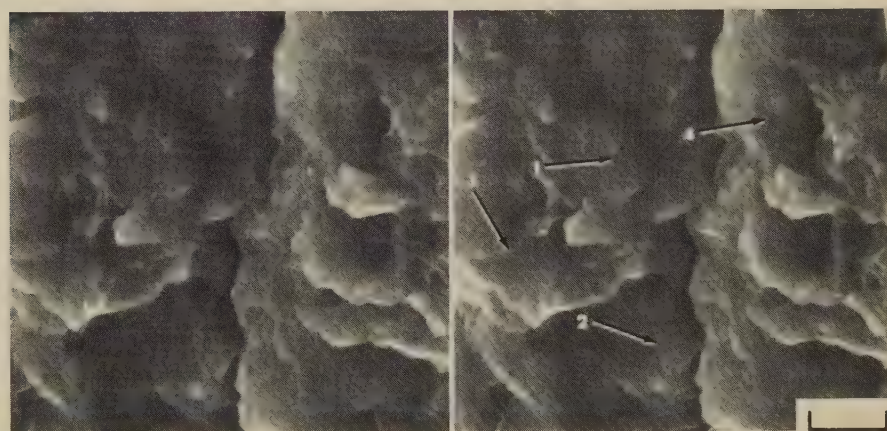
4232 Surface of a high-cycle fatigue crack in the same 4340 steel, with the same heat treatment and hardness, as in 4228-4229.

4233 The specimen was tested in tension at a maximum stress of 234 MPa (34 ksi) but was not fractured (a similar specimen broke at 75,000 cycles). This area of the surface is irregular and may have undergone rubbing in being opened up. In regions at arrows 1 and 2, the crack appears partly intergranular. Fatigue striations are faintly visible in the TEM pair at arrows 3 and 4, but none are resolved in the SEM. The match in topographies revealed by the two techniques is excellent; particular attention is called to the matching contours in the two views at arrows 5, 6 and 7. There appear to be several secondary intergranular cracks; some of these cracks, although they are more distinct in the TEM pair, are visible also in the SEM, whereas others can be seen only in the TEM. See also fractographs 4234-4235, below.

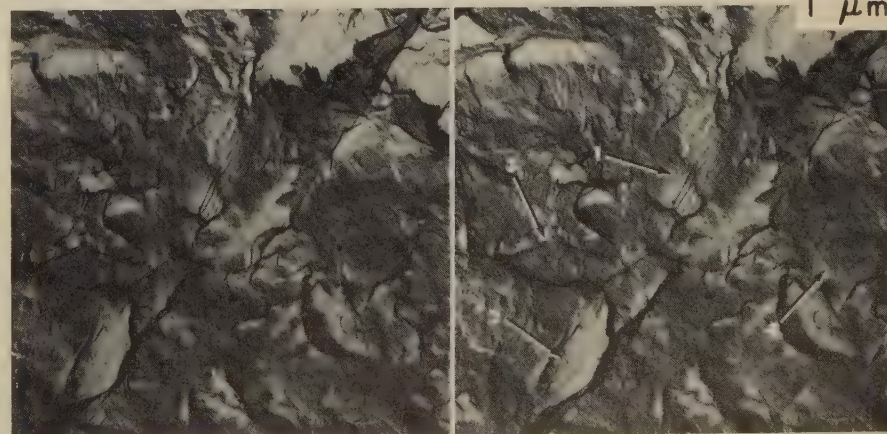
SEM (4234) and TEM (4235) stereofractographs 10,080×

4234 A more highly magnified set of views of another area in the high-cycle fatigue fracture in 4340 steel in 4232-4233. The fracture surface bears a few poorly defined fatigue striations and appears to have received considerable rubbing. A number of secondary cracks are evident, some of which seem to be intergranular.

4235 Comparison between the SEM and the TEM pairs is somewhat difficult, because features in the two views are oriented at different angles. However, careful scrutiny reveals that certain features are indeed common to both pairs, one of them being the patch of what appear to be fatigue striations at arrow 1. These are much more clearly visible in the TEM pair, because those in the SEM lack contrast. Another region of similar marks can be seen at arrow 4 in the TEM but cannot be discerned in the SEM. Other features identifiable in both pairs are marked by arrows 2 and 3.

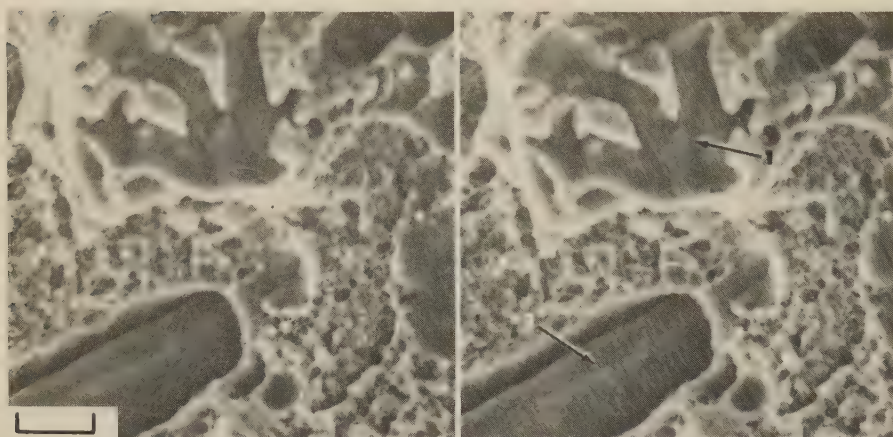
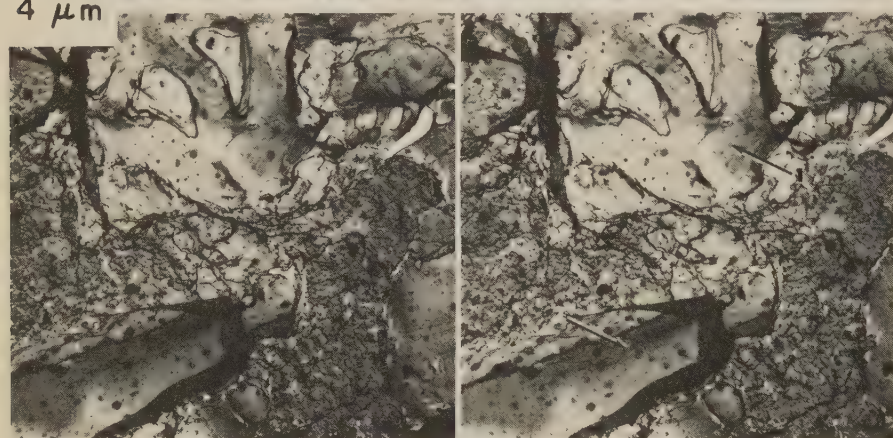
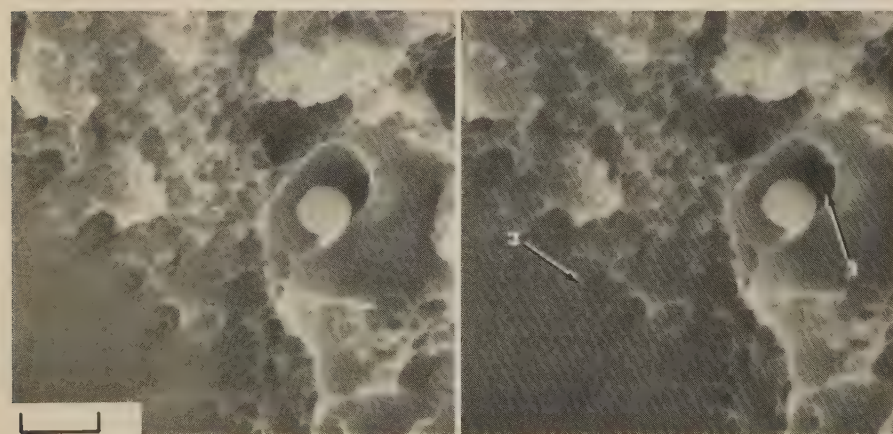
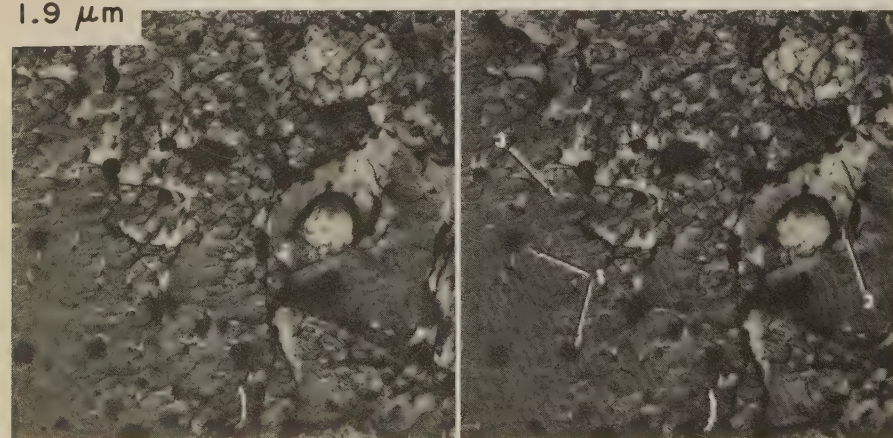
SEM (4236) and TEM (4237) stereofractographs 2500×

4236 Surface of a fracture produced at room temperature in a notched specimen of aluminum alloy 7075-T6 by tension overload at a crosshead speed of 0.002 in. per minute. The tensile strength of the specimen was 592.3 MPa (85.9 ksi). The surface shows quite fine equiaxed dimples surrounding sites of large second-phase particles. The conformity in contour between the SEM and the TEM stereo pairs is excellent, particularly when they are viewed in 3-D. Of especial interest is the area marked by arrow 1 near the top of each pair, which had been in contact with second-phase particles. Near the bottom, at arrow 2, is a second-phase particle in a cavity that has started to open up. Note that the dimples around the perimeter of this large particle show exact correspondence between the SEM and the TEM pairs. Also, the very tiny dimples in the TEM view resemble closely the appearance of those in the SEM. See also 4238-4239, below.

4238 Comparison SEM and TEM views of another area in the tension-overload fracture surface of aluminum alloy 7075-T6 shown in 4236-4237, at higher magnification. This surface contains equiaxed dimples, shear dimples, a stretched area, and second-phase particles. The dark spots at arrow 1 in the stretched area of the TEM replica are artifacts that undoubtedly resulted from the deposition of a foreign material during dissolution of the first-stage plastic replica. The SEM stereofractograph gives a better idea of the topography than does the TEM when the members of each pair are viewed individually, but both reproduction techniques afford equivalent perception of the contours when the views are observed in stereo. The TEM stereo pair shows more detail in the hole behind the second-phase particle at arrow 2 than is shown in the SEM. Equivalent detail in the SEM would be produced by a change of exposure. Arrow 3 marks an area where the TEM pair gives much fine detail of the shear dimples, which is not resolved in the SEM.

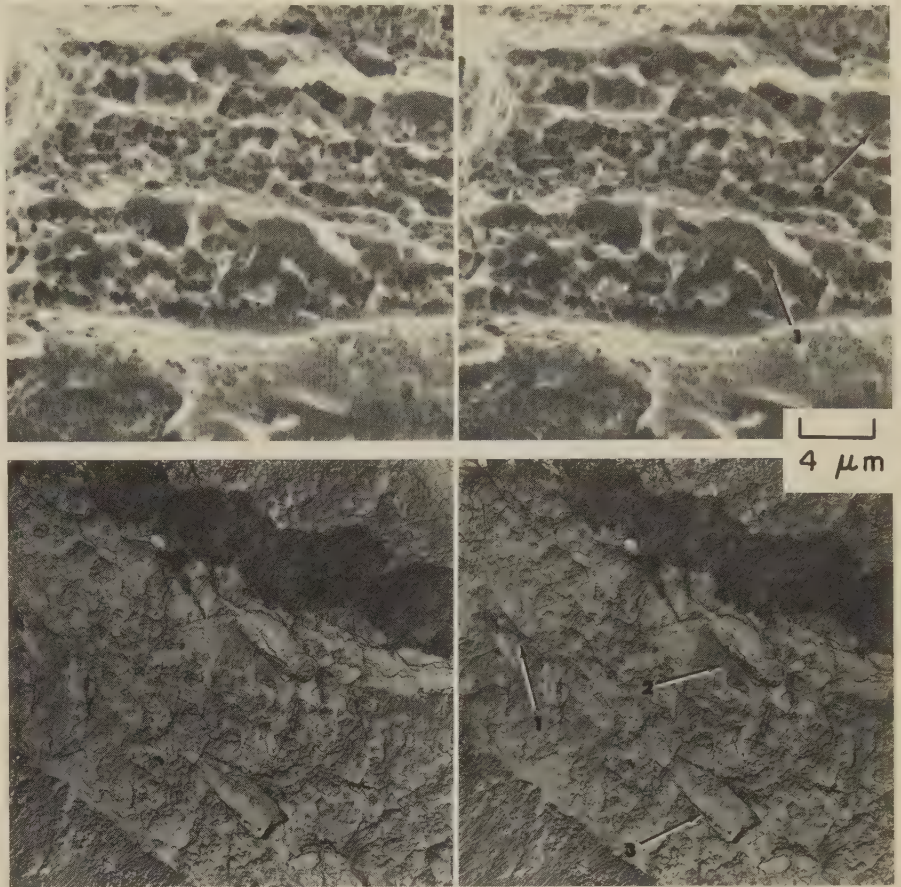
SEM (4240) and TEM (4241) stereofractographs 2520×

4240 Surface of a tension-overload fracture in a notched specimen of aluminum alloy 7075-T6 that, like the specimen shown in 4236-4237 and 4238-4239 (facing page), was tested at room temperature, but at a crosshead speed of 0.5 in. per minute — which is more normal. The surface, however, is somewhat similar to that of the specimen tested at the lower crosshead speed, containing equiaxed dimples and sites where second-phase particles exist or previously existed. Comparison of the SEM pair with the TEM pair is somewhat difficult because the orientation of view in the two pairs is at different angles and thus the two show areas that do not exactly coincide. Also, the dark band near the top of the TEM view (an artifact caused by tearing and overlapping of the carbon replica) alters its appearance. Study of the comparison views in stereo shows that the sharp edge of the abyss at the bottom of the SEM fractograph appears across the lower left corner in the TEM fractograph. Furthermore, it is evident that the sites marked by arrows 1 and 2 are the same features in the two reproductions. The second-phase particle at arrow 3 in the TEM view is not included in the SEM. See also 4242-4243, below.

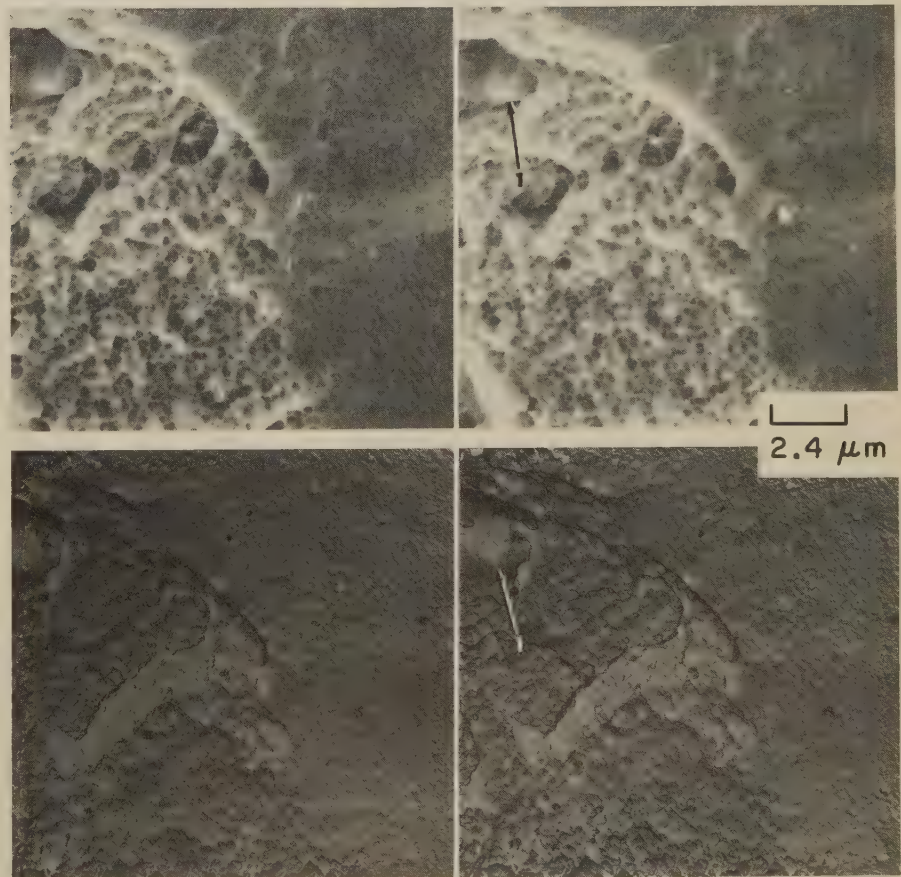
SEM (4242) and TEM (4243) stereofractographs 4200×

4242 Higher-magnification comparison views of another area in the tension-overload fracture of the notched specimen of aluminum alloy 7075-T6 discussed in 4240-4241. Like the surface shown in those stereofractographs, the area here also displays fine equiaxed dimples and, at arrow 1, what is apparently a second-phase particle. A large portion of this area is a relatively smooth incline that may be a previous interface with a very large second-phase particle. The views shown by the SEM and the TEM pairs are in exact agreement, and individual dimples can be identified in the two surface reproductions. As is evident in many of these examples, the heights and depths of the topography as portrayed by the SEM are materially more pronounced than the counterparts portrayed by the TEM.

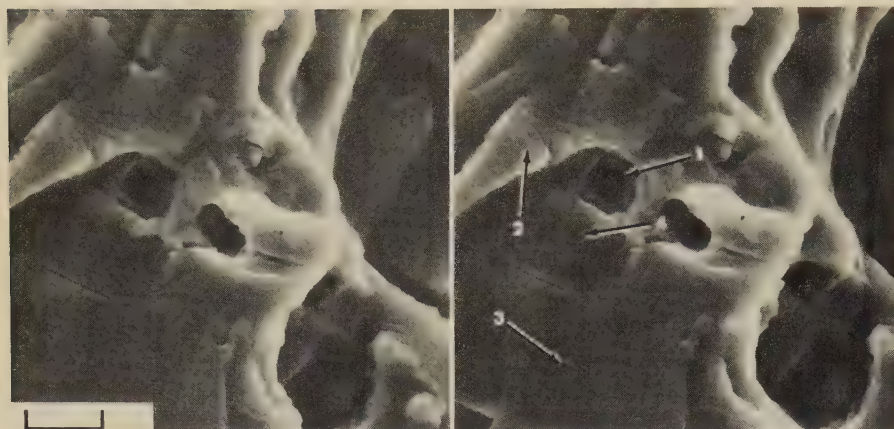
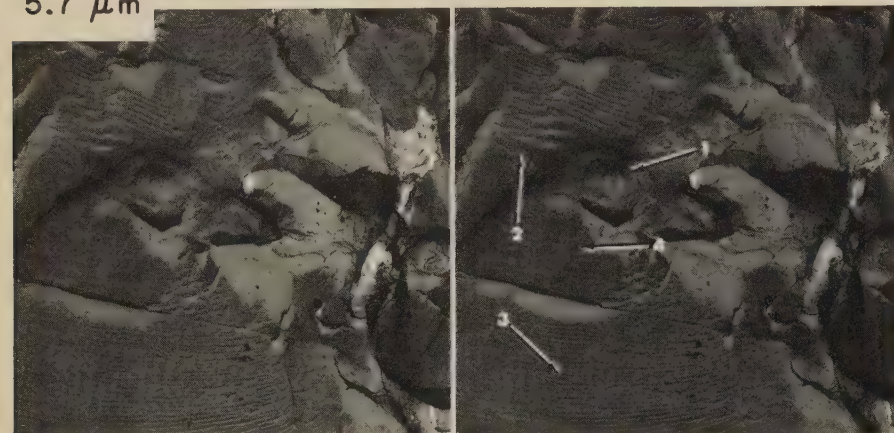
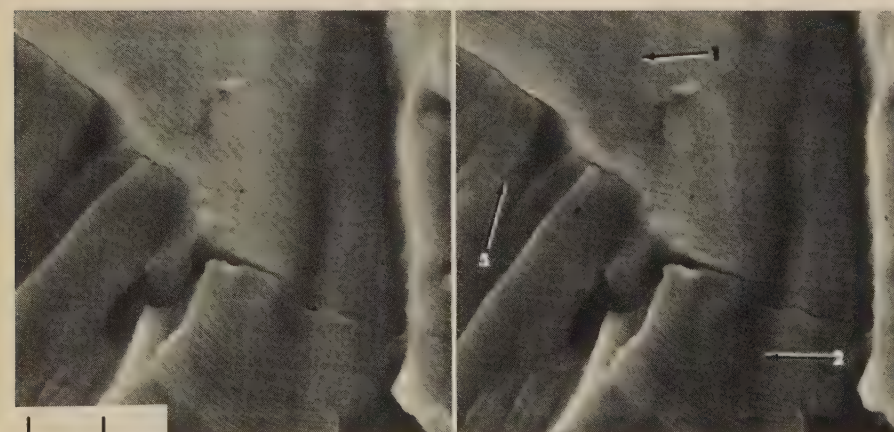
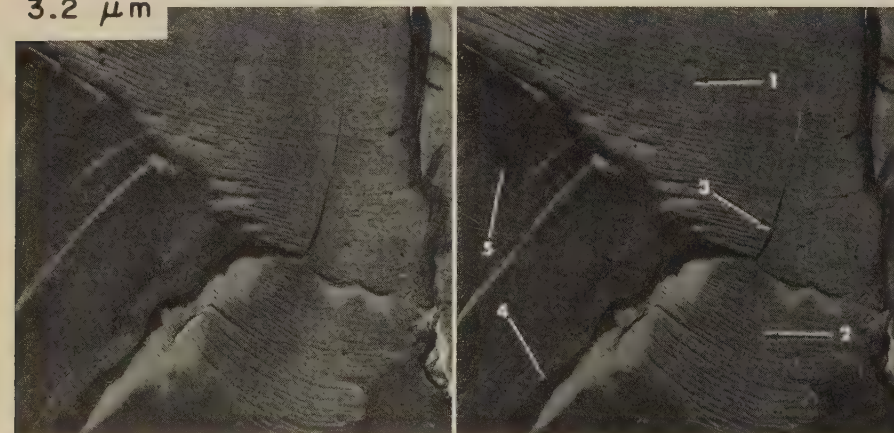
SEM (4244) and TEM (4245) stereofractographs 1760×

4244 The first of four sets of views, at increasing magnification, showing four areas of the surface of a low-cycle fatigue-test fracture in aluminum alloy 7075-T6 obtained with a maximum loading of 117 MPa (17 ksi) at 1900 cycles per minute. Fracture occurred at 600,000 cycles. The tensile strength of the material was 586 MPa (85 ksi). The fracture surface is characterized by well-defined fatigue striations and prior sites of second-phase particles. There appear to be secondary cracks—possibly of an intergranular nature. The topographic details in the area shown here (for example, the contour at arrow 1) can be easily recognized in both the SEM and the TEM pairs. The fatigue striations show differences that are characteristic of the two reproduction techniques. The striae are readily identified in both fractographs at arrow 2. Careful scrutiny of the SEM fractograph shows the striations that are sharply outlined at arrow 3 in the TEM. At arrow 4, the TEM pair displays very fine striations that are not resolved in the SEM. See also 4246-4247 (below) and 4248-4249, 4250-4251 (next page).

4246 A higher-magnification set of views showing another area of the surface of the low-cycle fatigue-test fracture in aluminum alloy 7075-T6 in 4244-4245. The fracture surface here is made up of several fatigue-striation patches. In the regions at arrows 1 and 2, the striations are shown quite clearly in both the SEM and the TEM pairs, but their contours are much more sharply defined in the TEM. Arrows 3 and 4 designate locations where the TEM replica was torn or overlapped. In the narrow fatigue patches at left in these views, the fatigue striations that are easily seen in the TEM pair are seen with difficulty at arrow 5 in the SEM. These striations could be brought out more clearly in SEM reproduction with more favorable contrast and a more desirable angle of illumination by the electron beam. However, the resolution attainable with the SEM technique is not comparable to that attainable with the TEM.

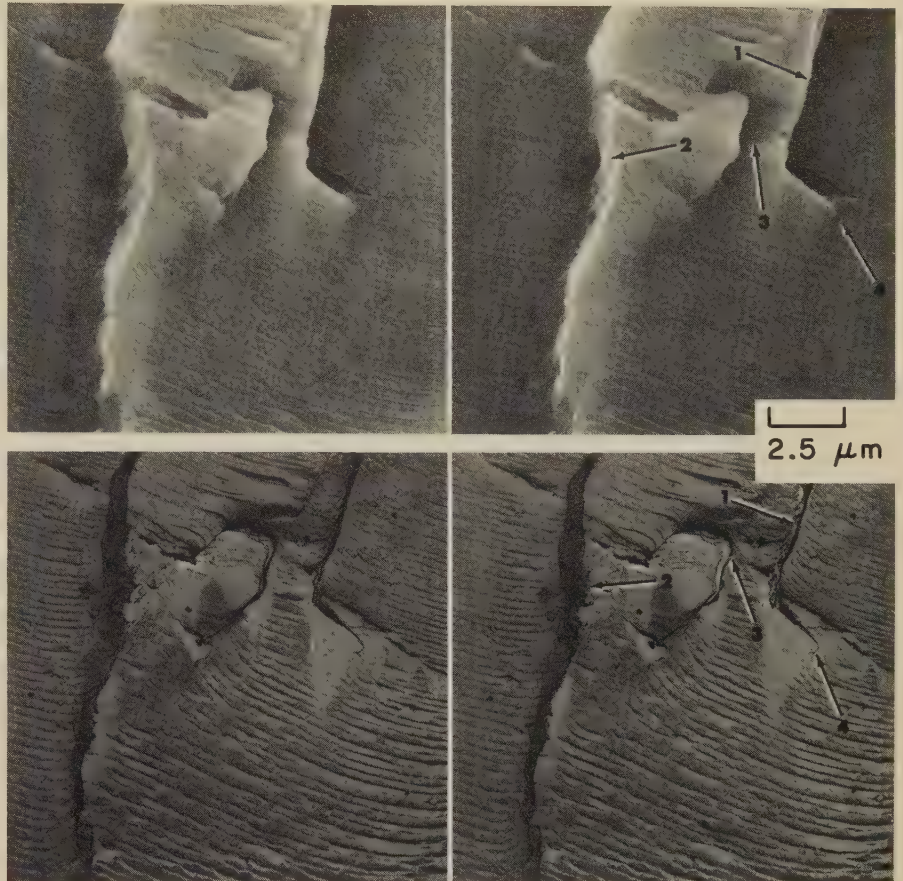
SEM (4248) and TEM (4249) stereofractographs 4000×

4248 A third set of views, at still higher magnification, showing another area of the surface of the low-cycle fatigue-test fracture in aluminum alloy 7075-T6 in 4244-4245 and 4246-4247. In this area the fracture surface shows well-defined fatigue striations that are clearly visible in both the SEM and the TEM pairs but with more detail and contrast in the TEM. Note the excellent match of the reproductions made by the two techniques. The vertical surface at arrow 1 is quite accurately registered in the TEM fractograph, but at the other side (at arrow 2) the replica has been torn. The detail in the crevices marked by arrows 1 and 3 is more clearly displayed in the TEM pair but could be matched in the SEM if the exposure were adjusted for this purpose. The sharp line at arrow 4 in the TEM fractograph bears some resemblance to a replica tear, but it is also visible in the SEM and actually is a secondary crack in the aluminum. See also 4250-4251 (below).

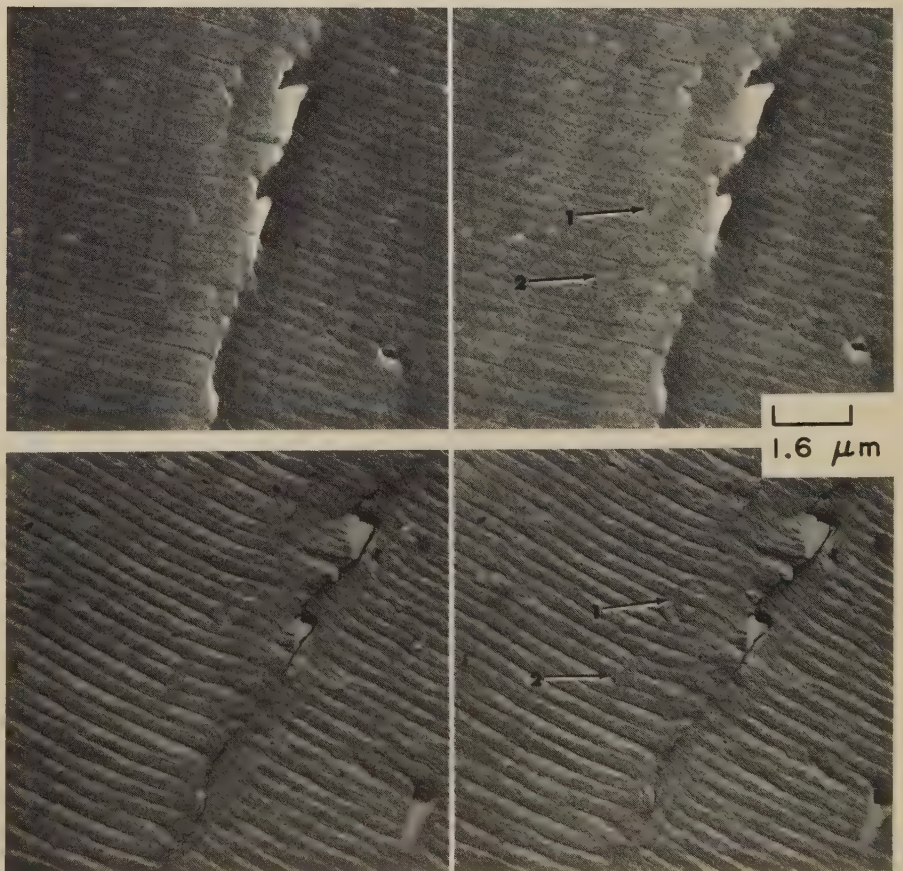
SEM (4250) and TEM (4251) stereofractographs 6400×

4250 A fourth set of views, again at higher magnification, showing a fourth area of the surface of the low-cycle fatigue-test fracture in aluminum alloy 7075-T6 in 4244-4245, 4246-4247 and 4248-4249. This region of the fracture surface shows portions of two fatigue patches separated by a sizable step. At this magnification, much of the detail of the striations is visible in both the SEM and the TEM fractographs. Note the slight indentation marks that can be seen at arrows 1 and 2; these of course are much more clearly defined in the TEM pair. The gray mark below the cavity at lower right in the TEM was produced during shadowing of the replica, a negative surface in which the cavity in the specimen was reproduced as a projection. The height of the step at the juncture of the two fatigue patches is shown to be much greater in the SEM than in the TEM pair; this is the result of replica "collapse".

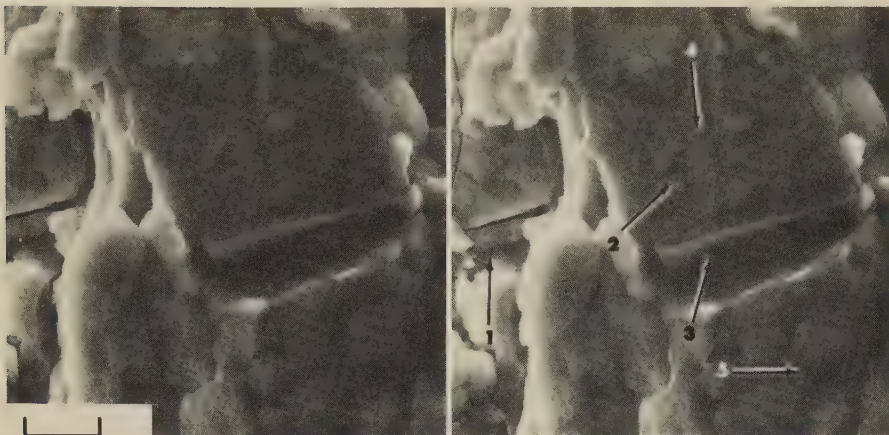
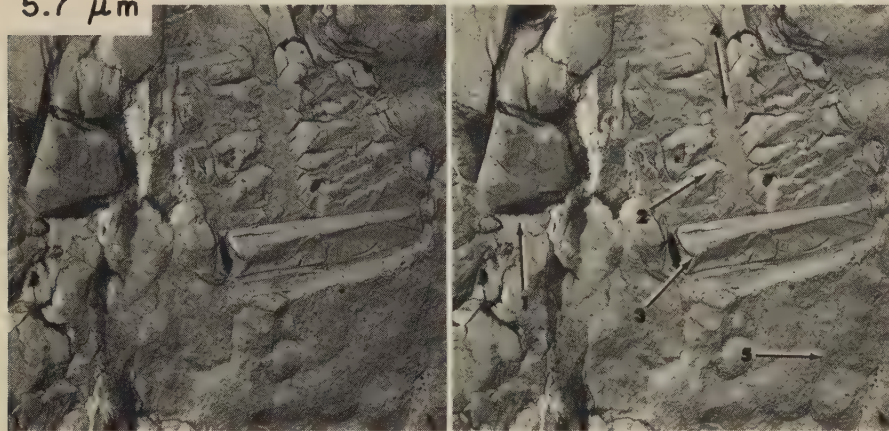
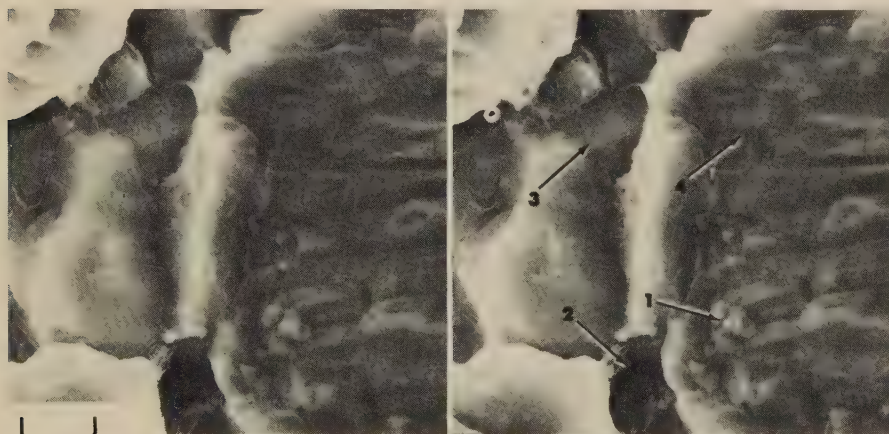
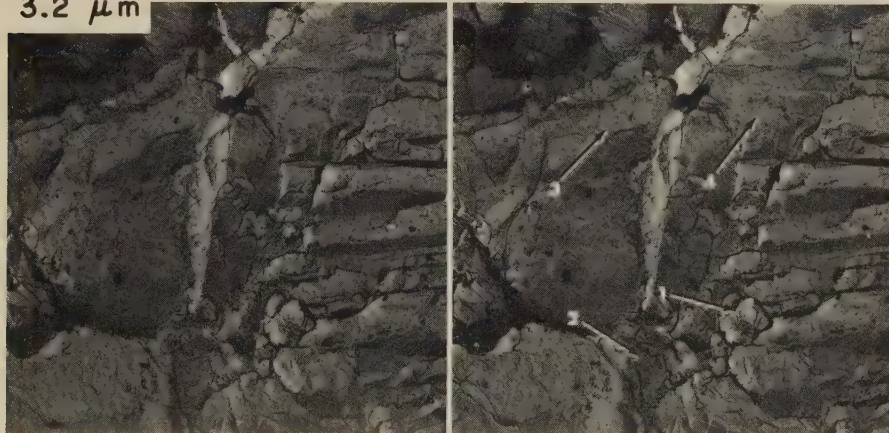
SEM (4252) and TEM (4253) stereofractographs 1760×

4252 The first of four sets of views, at increasing magnification, of four areas of the surface of a fracture resulting from stress-corrosion cracking in aluminum alloy 7075-T6 exposed to water at room temperature and to stress (maximum not reported) by hydrostatic pressure. The tensile strength of the material was 586 MPa (85 ksi). This region of the fracture surface shows intergranular separation, minute corrosion pits on grain surfaces, second-phase particles, and general freedom from accumulations of corrosion debris. When viewed in 3-D, the SEM pair shows that the left edge of this area is much lower than the central region (compare regions at arrows 1 and 2). This difference in elevation is not apparent in the TEM fractograph, indicating collapse of the replica. Arrow 3 indicates a second-phase particle, and arrow 4 designates a site previously occupied by another. The corrosion pits that are clearly visible in the TEM pair near arrow 5 are not resolved in the SEM. See also 4254-4255 (below) and 4256-4257, 4258-4259 (next page).

4254 A higher-magnification set of views showing a different area of the surface of the fracture resulting from stress-corrosion cracking in aluminum alloy 7075-T6 in 4252-4253 (above). In this area of the surface, fracture is mainly intergranular, complicated by flat facets at the right that are prior interfaces between the matrix and bar-shaped second-phase particles. There appears to be very little corrosion debris. The detail shown in the SEM pair is remarkably identical to that resolved in the TEM. Observe that the fine detail around the tiny prong at arrow 1 can be recognized in both the SEM and TEM pairs; the same conformance is true in the deep depression at arrow 2. Some of the corrosion pits near arrow 3 can be identified in the SEM fractograph, but those in the region of arrow 4 can be seen only in the TEM. Again, the true differences in elevation, which are shown in the SEM pair, are not registered in the TEM because of replica collapse.

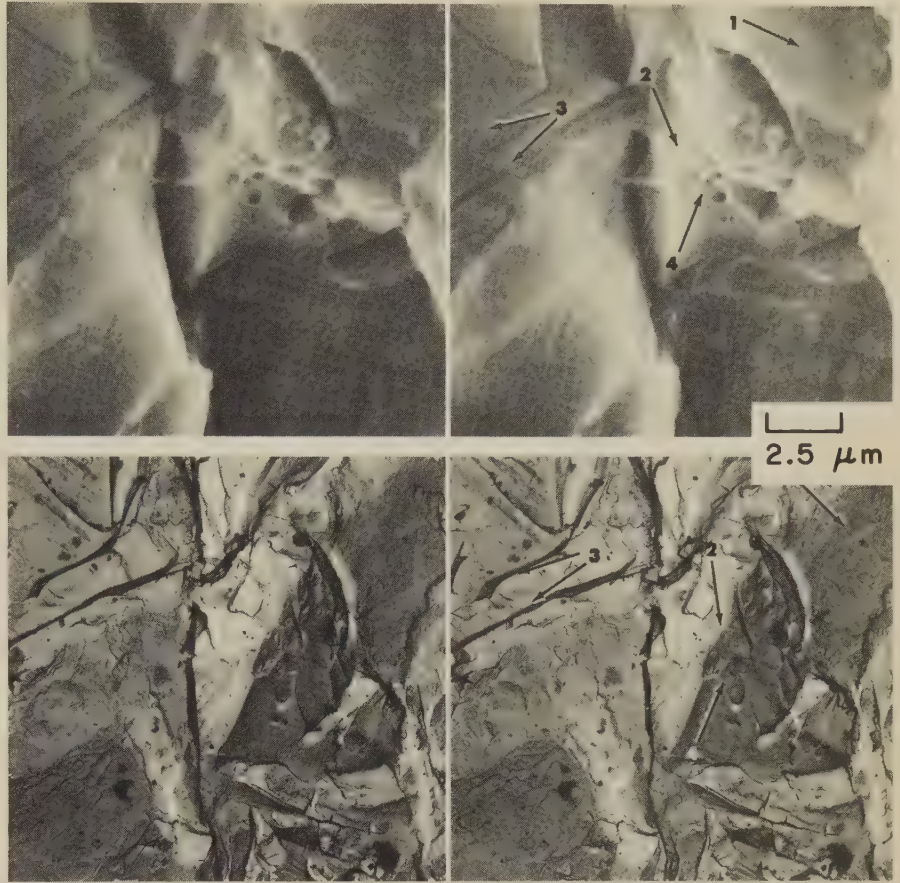
SEM (4256) and TEM (4257) stereofractographs 4000×

4256 A set of views, at even higher magnification, of a third area of the fracture caused by stress-corrosion cracking in aluminum alloy 7075-T6 in 4252-4253 and 4254-4255. In this area, the fracture surface is markedly intergranular, contains several secondary cracks (some of which appear to be transgranular), exhibits some corrosion pits but little corrosion debris, and contains local regions of moderate-size dimples. In general, the reproduction of surface contours in the TEM pair matches very closely that in the SEM. However, mismatch is evident at regions affected by replica collapse; for example, the region at arrow 1 (as viewed in 3-D) appears to be higher than the region at arrow 2 in the SEM pair but lower than the region at arrow 2 in the TEM. Note the excellent agreement between the two techniques in registering the secondary cracks at arrow 3 and the details of the dimples at arrow 4. However, very few corrosion pits are resolved in the SEM pair. See also 4258-4259 (below).

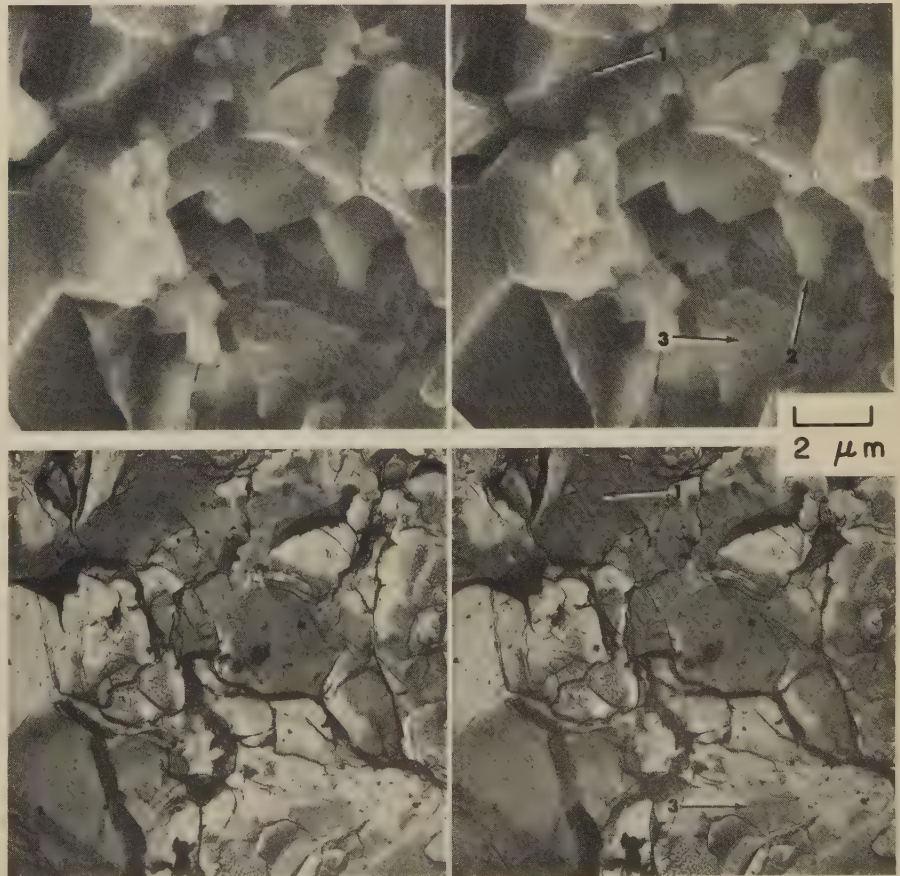
SEM (4258) and TEM (4259) stereofractographs 5000×

4258 A fourth set of views, again at higher magnification, showing another area of the stress-corrosion-cracking fracture in aluminum alloy 7075-T6 shown in 4252-4253, 4254-4255 and 4256-4257. Similar to the three preceding sets, this set of views shows a variety of grain surfaces resulting from intergranular rupture. The TEM fractograph shows many minute corrosion pits on these separated-grain surfaces, none of which are resolved in the SEM pair. The dark zones between grains in the TEM pair are caused by folding of the replica at secondary cracks. Observe the excellent agreement between the SEM and TEM pairs as to contour and detail, particularly in the region at arrow 1. Arrow 2 marks a feature in the SEM that does not appear in the TEM, which is unusual. Again, differences in elevation are minimized in the TEM; the region at arrow 3 appears to be at the same level as the ridge above arrow 1 whereas the SEM shows that the region at arrow 3 is much lower.

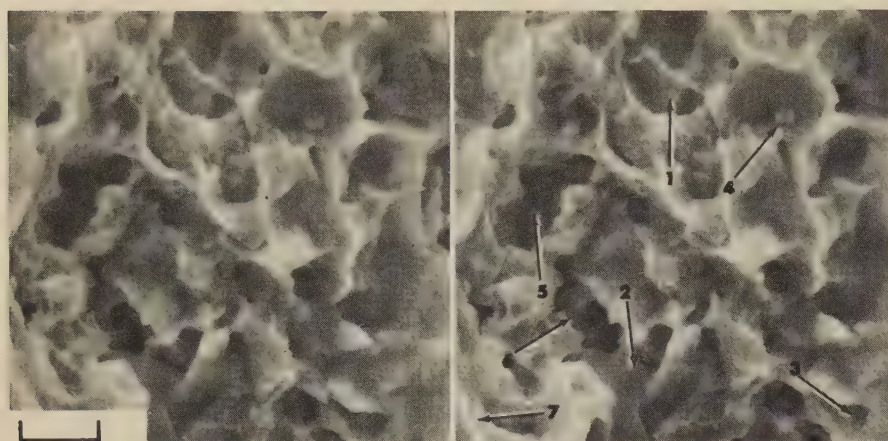
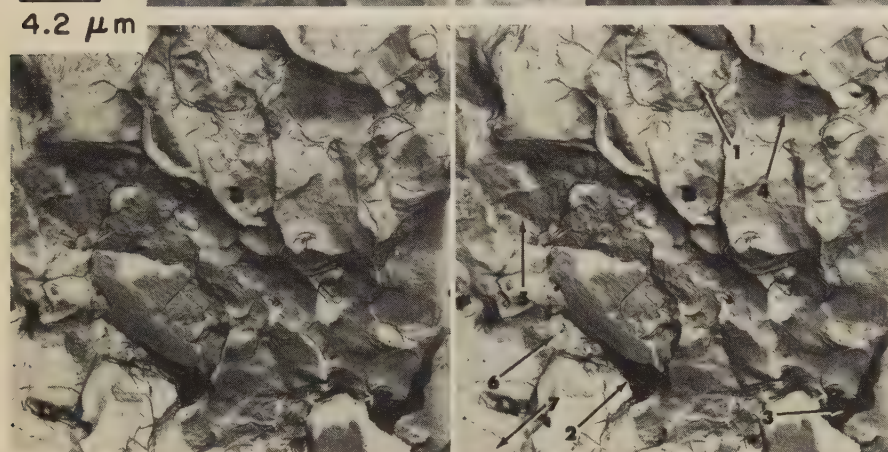
SEM (4260) and TEM (4261) stereofractographs 2400×

4260 Surface of a tension-overload fracture in a notched specimen of annealed Ti-8Al-1Mo-1V alloy that was broken at room temperature. The tensile strength of the material was 1000 MPa (145 ksi). The fracture surface consists of dimples of various sizes, a few of which show some sidewall stretching. The SEM and TEM pairs are in close agreement as to details of contour; compare, for example, the contours in and around the depression at arrow 1. In the TEM fractograph, tears and folds in the replica obscure the surface in the crevices at arrows 2 and 3. Note that the cube-shaped second-phase particle at arrow 4 in the SEM is missing entirely from the TEM. Many superficial surface features that are clearly visible in the TEM pair are not resolved in the SEM. Some replica collapse is evident when the elevations at arrows 5, 6 and 7 in the TEM fractograph are compared with those in the SEM. See also 4262-4263 (below).

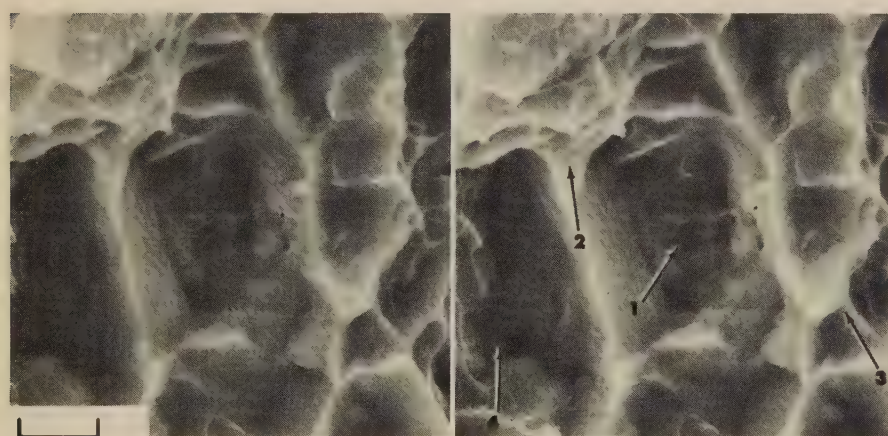
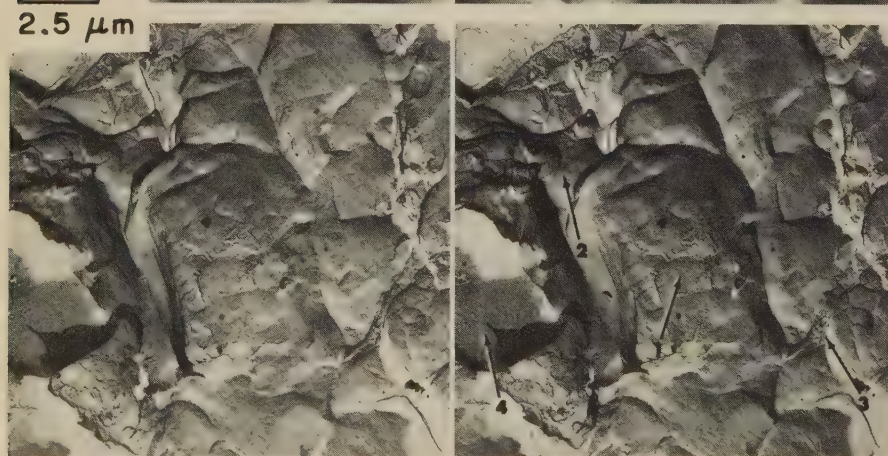
4262 A more highly magnified set of views of a different area of the surface of the tension-overload fracture in annealed Ti-8Al-1Mo-1V alloy shown in 4260-4261 (above). This area shows rather large dimples. For the most part, the topographic agreement between the SEM and TEM pairs is very close, as may be seen by comparing the contours at arrows 1, 2 and 3. Note that the stretch marks on the left side of the cavity at arrow 2 are clearly visible in both pairs. Elsewhere, however, similar marks are largely unresolved in the SEM fractograph. The feature at arrow 4 in the TEM is not a fracture contour but is an artifact caused by a bubble entrapped in the plastic replica. The dark regions above and below this artifact are the result of folds in the carbon replica. The SEM fractograph shows the true surface at arrow 4.

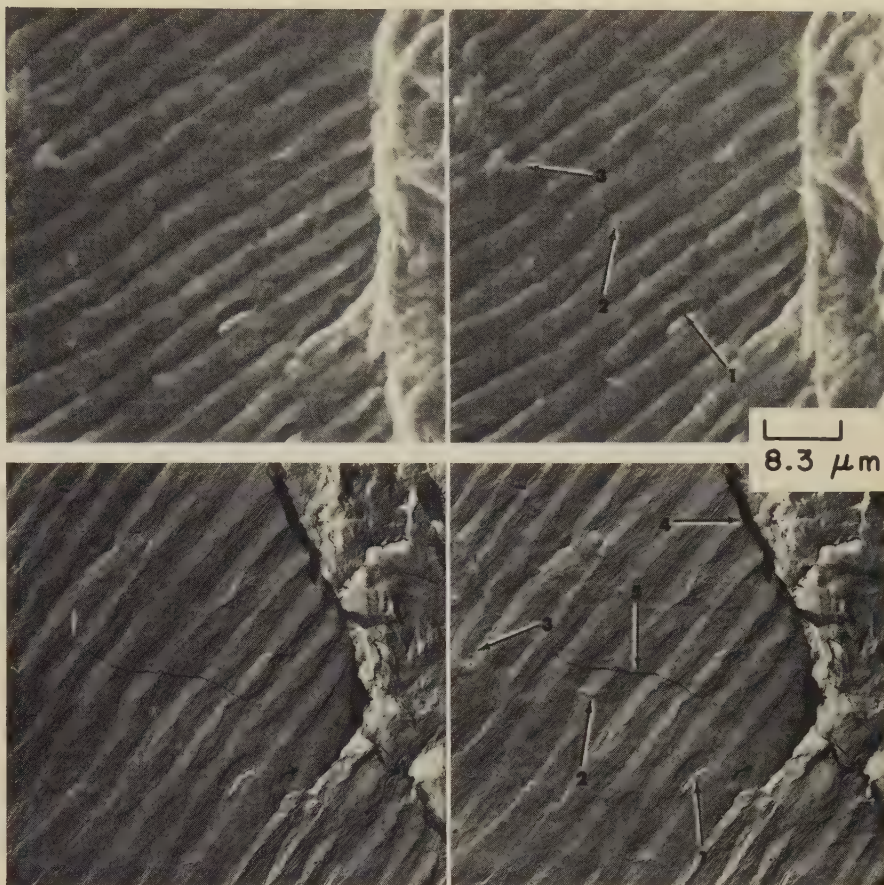
SEM (4266) and TEM (4267) stereofractographs 3100×

4266 A more highly magnified set of views of another area of the surface of the high-cycle fatigue fracture in annealed Ti-8Al-1Mo-1V alloy in 4264-4265 (above). These stereofractographs show the junction of two adjacent fatigue-striation patches that exhibit considerable irregularity in striation orientation in the neighborhood of the step separating the patches. Comparison of the SEM and TEM pairs shows good agreement in registry of contours, as may be seen at arrows 1, 2 and 3. The fine marks along the ridges of the striae are sufficiently pronounced for many to be shown in the SEM fractograph, but others are not resolved there and are shown much more distinctly in the TEM pair.

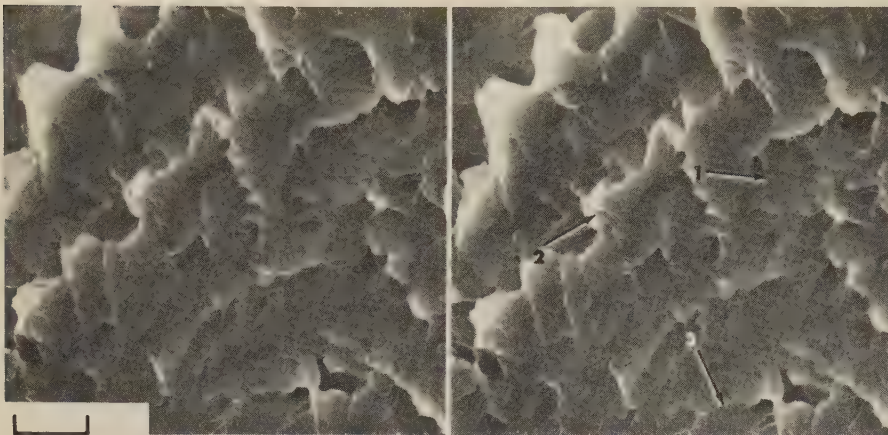
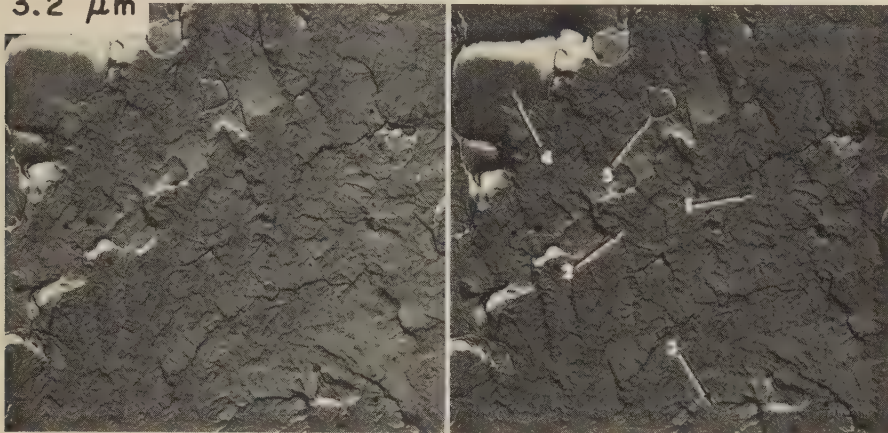
SEM (4268) and TEM (4269) stereofractographs 3100 \times

4268 Stress-corrosion fracture in a specimen of the same annealed titanium alloy Ti-8Al-1Mo-1V as for 4260 to 4267 (preceding two pages). This specimen was subjected to a maximum stress of 170 MPa (25 ksi) while exposed to an environment of 3½% NaCl in water, at room temperature. The fracture surface possesses many small and slightly offset facets, such as those at arrows 1 and 2, that appear to be quasicleavage facets. Many of the features along the edges of these facets, however, show dimple-like characteristics. Serrated ranks of the facets are separated by larger steps, although the fracture-surface area here is not large enough to show how repetitive these tiers may be. Agreement in contour details between the SEM view and the TEM view is very good, as may be seen by comparing the surfaces at arrows 1, 2 and 3. The feature in the upper left corner of the TEM stereo pair, at arrow 4, is an artifact created by entrapment of a gas bubble in the plastic-replica medium. Another feature not common to both the SEM and the TEM views is the apparent artifact at arrow 5 in the TEM. See also 4270-4271, below.

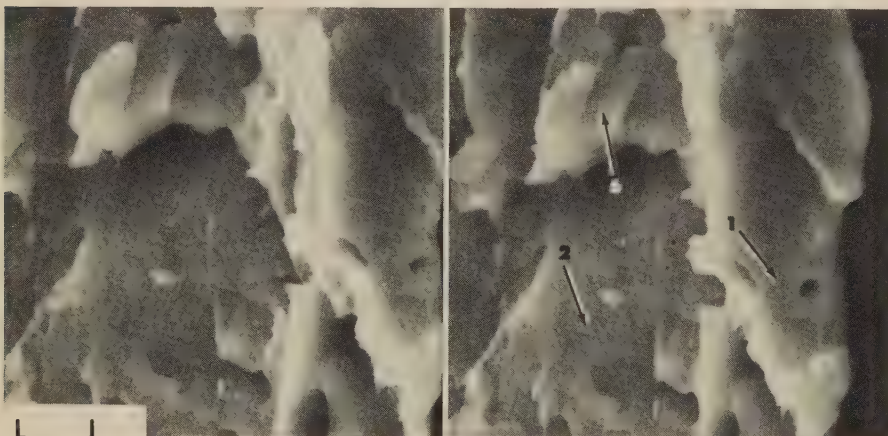
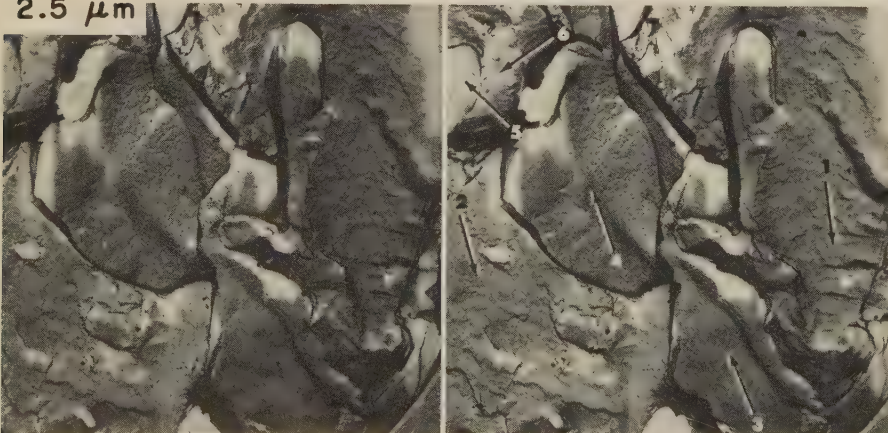
SEM (4270) and TEM (4271) stereofractographs 4000 \times

4270 A higher-magnification set of views in another area of the stress-corrosion fracture of the annealed Ti-8Al-1Mo-1V specimen of fractographs 4268-4269 (above). This area is somewhat similar to that shown at the lower magnification in 4268-4269, exhibiting rows of modest-size quasicleavage facets at different levels. Some of these facets, as at right, are separated by steps of appreciable height. There is excellent agreement in surface features between the SEM and the TEM pairs in the high-level region at arrow 1 at right, and in the lower-level region at arrow 2. The surface details at arrows 3, 4 and 5 in the TEM view, however, are artifacts resulting either from bubbles or foreign material trapped by the replica. The small facet at arrow 6 is the portion of this region that is common to both the SEM and the TEM fractographs. The surfaces that are real show essentially no accumulation of corrosion debris.
